# GRAVITY GRADIENT STABILIZATION SYSTEM for the

APPLICATIONS  
TECHNOLOGY  
SATELLITE

## SIXTH QUARTERLY PROGRESS REPORT

SIXTH QUARTERLY PROGRESS REPORT  
FOR THE  
APPLICATIONS TECHNOLOGY SATELLITE  
GRAVITY GRADIENT  
STABILIZATION SYSTEM

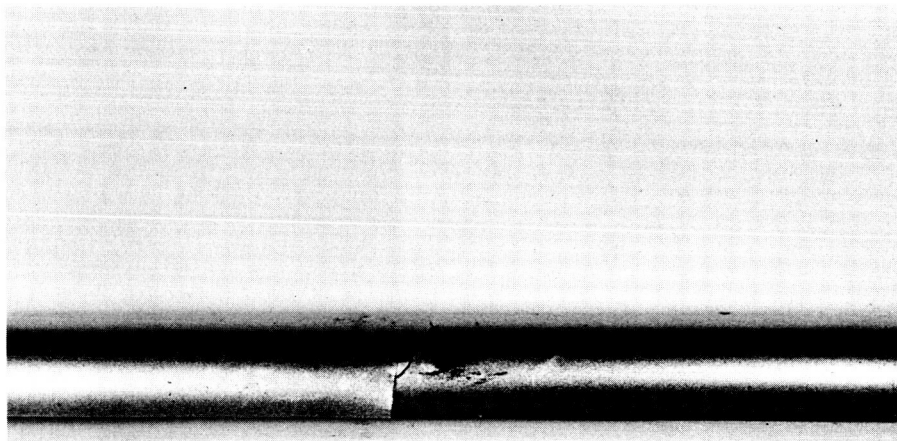
Figure 3-15. Typical Boom Crack at Drum Support Roller

Both sideplates of the disassembled erection unit (Boom 2) were found to be similarly affected. The Boom 1 drum bearings were found to be hung-up in a like manner but this unit was not completely disassembled at the time.

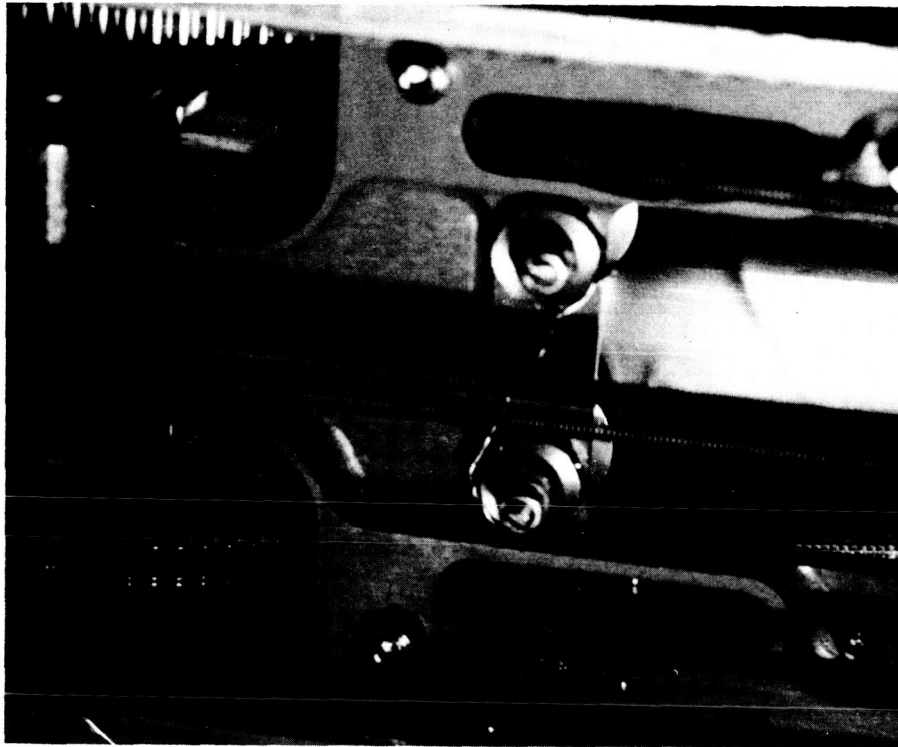
Figure 3-18. Wrinkle Pattern Developing in Boom,  
Internal to Guidance

- d. The wrinkle pattern (as in Boom 2) was found on the deployed position of the boom but not on the undeployed portion, indicating that misalignment between drum and guidance caused the wrinkling.

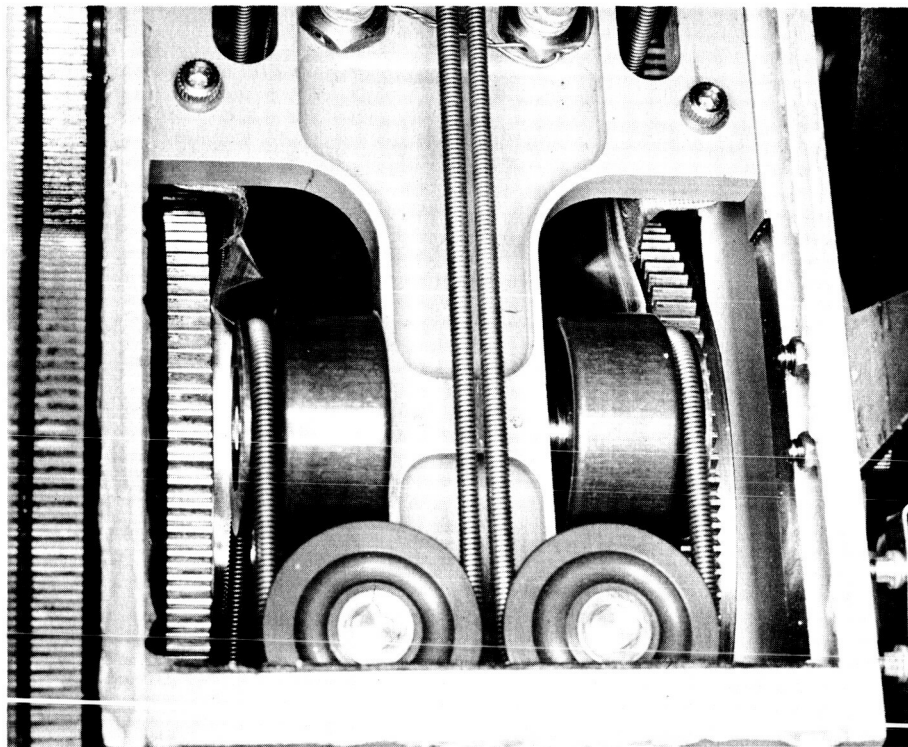
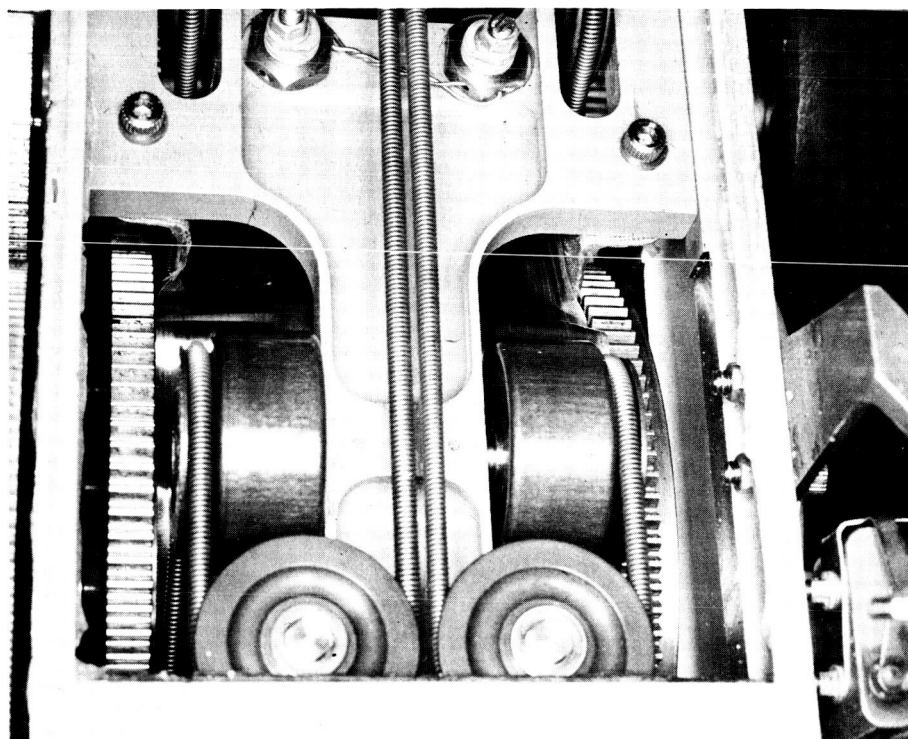
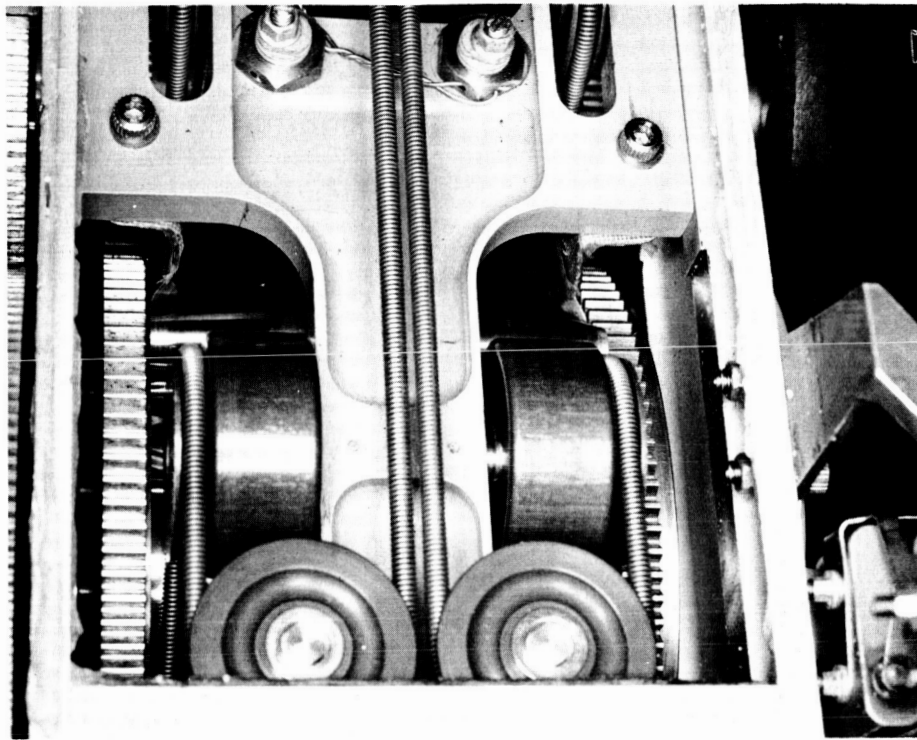
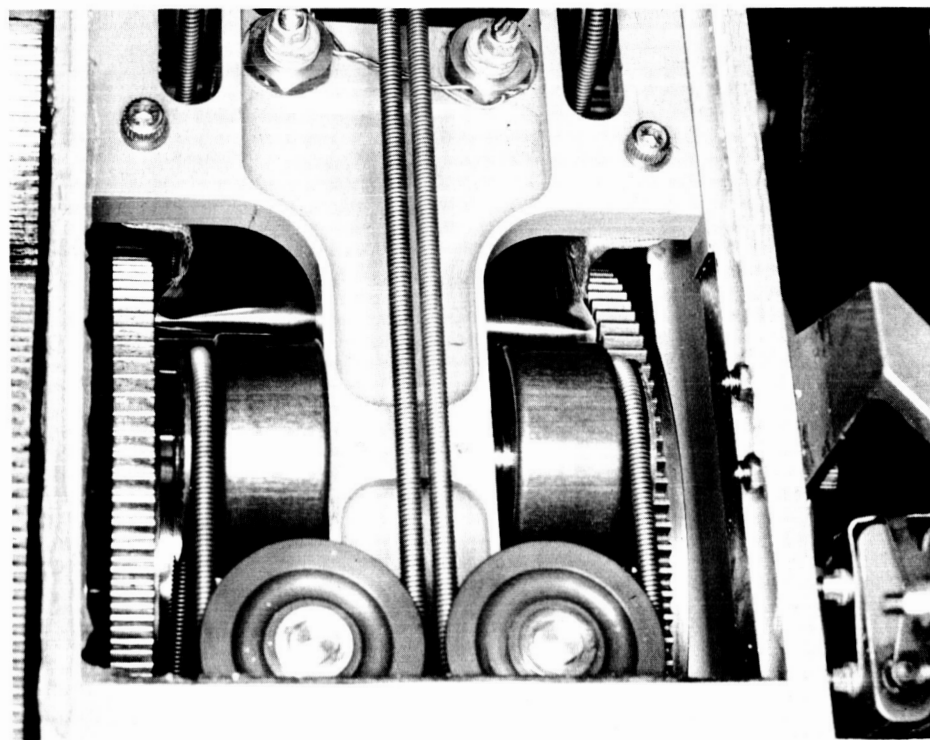
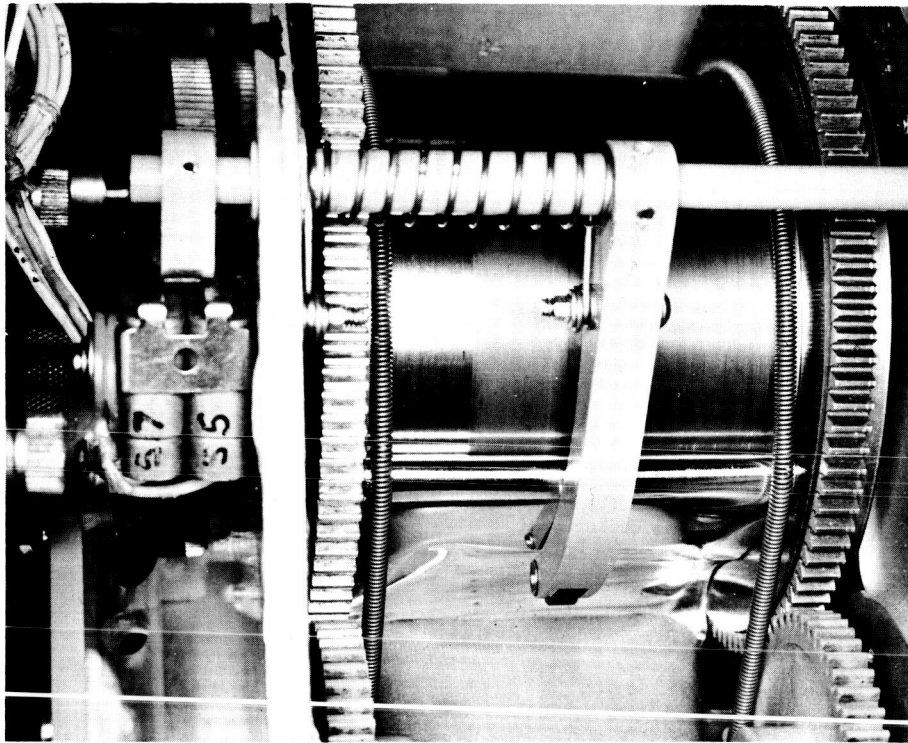
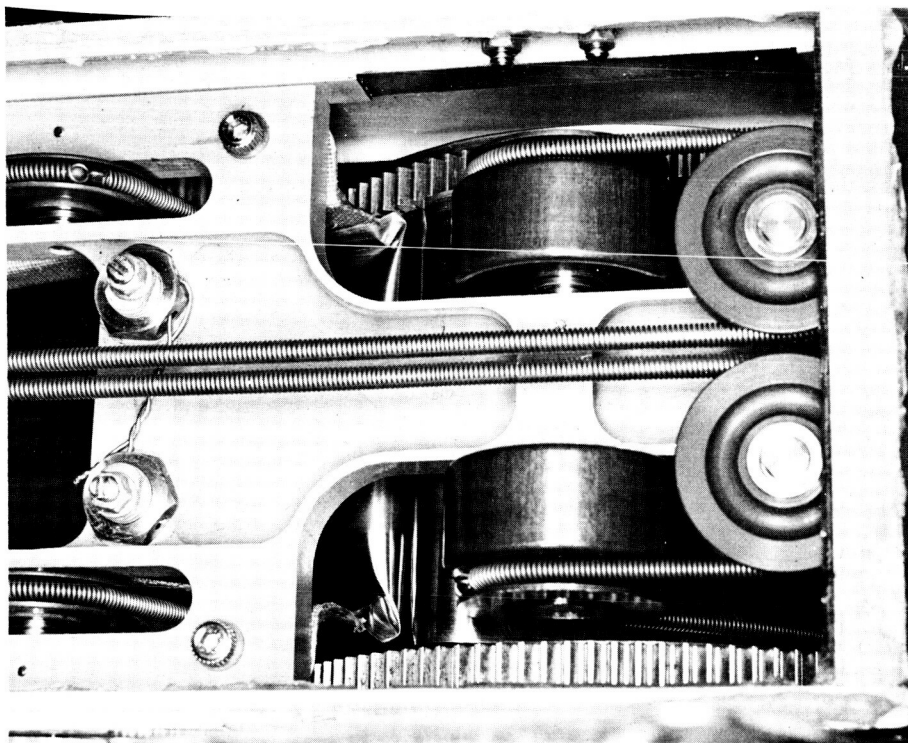
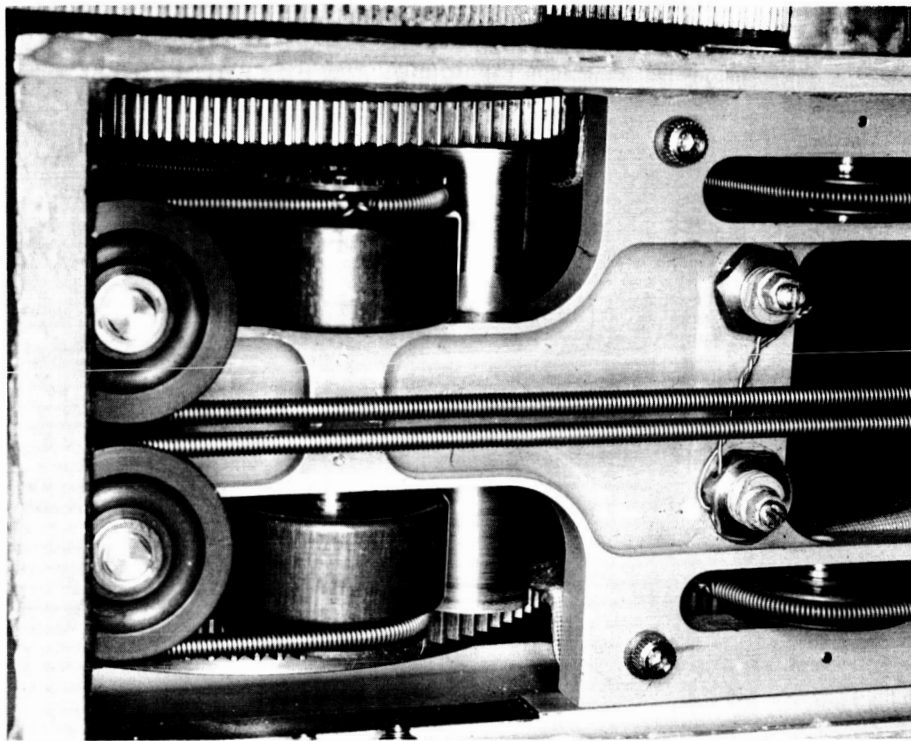
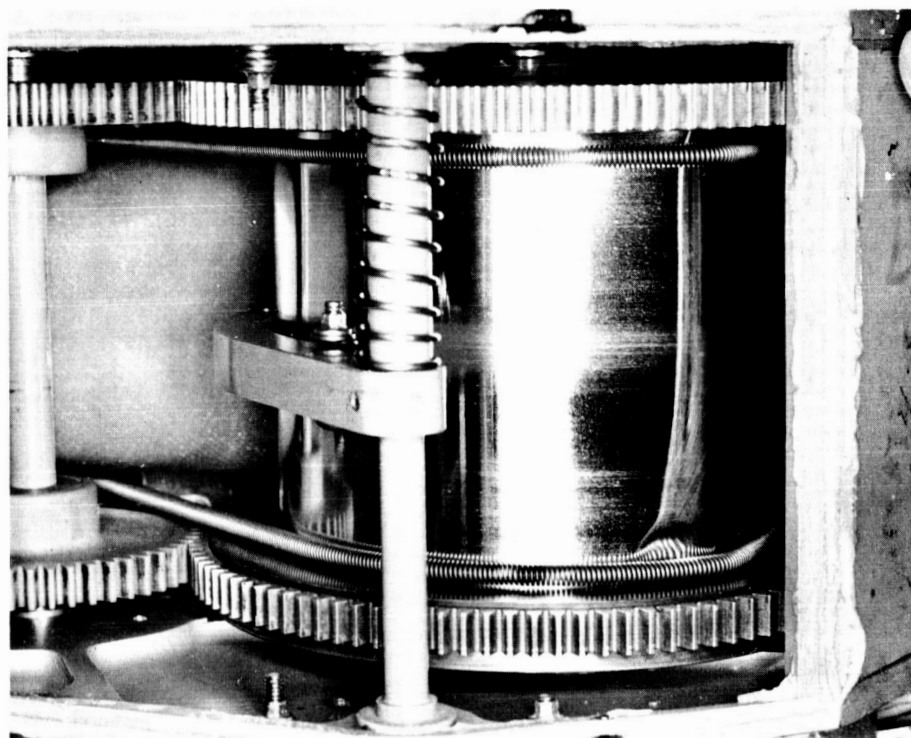
Since speculation existed that the reverse wind type failure experienced by Boom 2 might not be entirely due to the drum hang-up, an attempt was made to repeat the failure on Boom 1 in a manner conducive to close observation. Accordingly, the unit was set up at the test track and the drum drive gear was manually driven, while disconnected from the drive motor. Figures 3-24 through 3-31 show the results of this test. The sequence is as follows:

- a. The reverse-wind failure was duplicated with no unit discrepancies except drum/guidance misalignment due to kidney slot hang-up.
- b. No edge damage (crack) was evident before or after test.
- c. The ductile tear as in Boom 2 was not duplicated but this could be attributed to the vast difference in deployment speeds.

It was therefore concluded that the kidney slot hang-up (and resultant misalignment) is the problem to be attacked in precluding the reverse-wind failure. The redesign for this condition is to provide a much larger bearing area under the flange and a chamfer as shown in Figure 3-32.

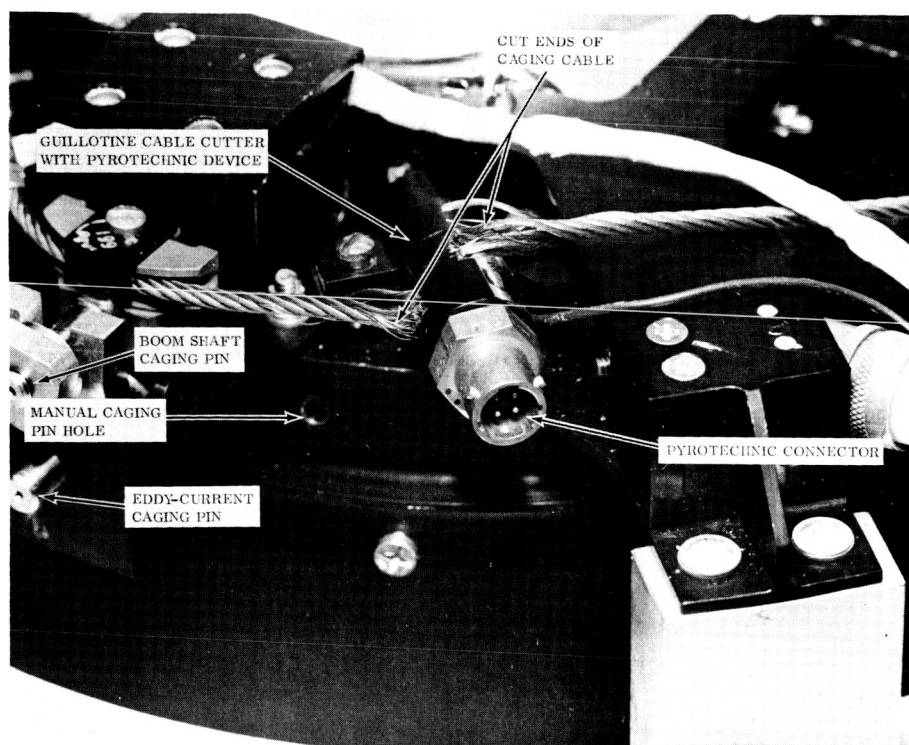
Figure 4-9. Caging Cable (at Pyrotechnic Device 1) After Uncaging Operation, CPD Engineering Unit 1

The first test performed following assembly of Engineering Unit 1 was an uncaging exercise. The guillotine cable cutters were electrically detonated. Figure 4-9 shows that all strands of the caging cable were completely cut by the uncaging guillotine. The right-hand part of the caging cable was placed on top of the baseplate especially for this picture: it is normally threaded through a clearance hole in a web of the baseplate. The connector on the right with its white power leads and dark ground wire was disconnected from the pyrotechnic device at the time the picture was made. When connected for firing,

this connection would normally be inserted into the bayonet end of the pyrotechnic device shown at the center of the picture. (Figure 4-4 shows connector mated.) The bracket with four holes (shown in left of picture) is used for the boom release mechanism. The boom mechanism release is shown in Figure 4-4. The square nut, at the left-hand edge of Figure 4-9, is on the end of the boom caging pin and is used to adjust the force on the eddy-current caging pin which, in turn, is located just below. The open hole, identified in Figure 4-9, is used for the manual caging pin.

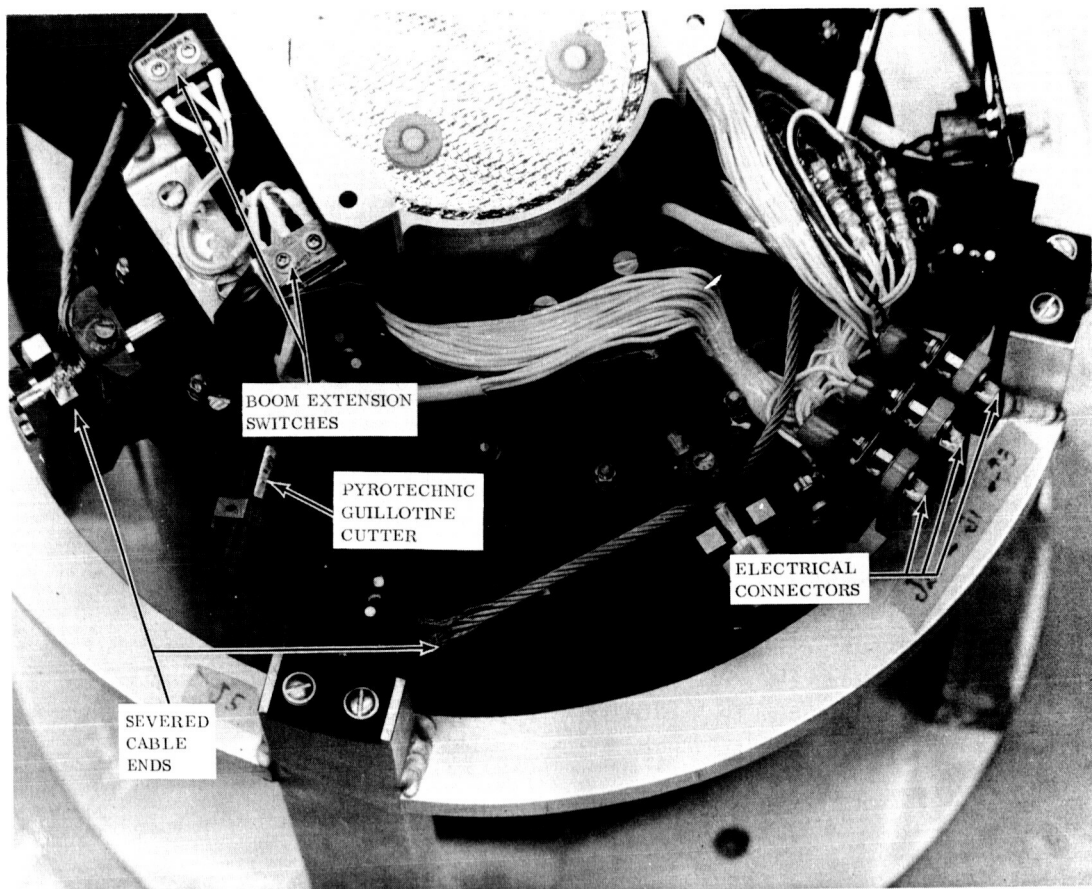
Figure 4-10. Caging Cable and Baseplate (with Pyrotechnic Device 2)  
After Uncaging Operation, CPD Engineering Unit 1

Figure 4-10 shows the opposite caging cable again completely severed. The wiring (along with the conformal coating which holds the wiring), the connectors, and the boom extension switches are also shown. The thermal insulation in the center of the boom shaft can be seen at the top center.

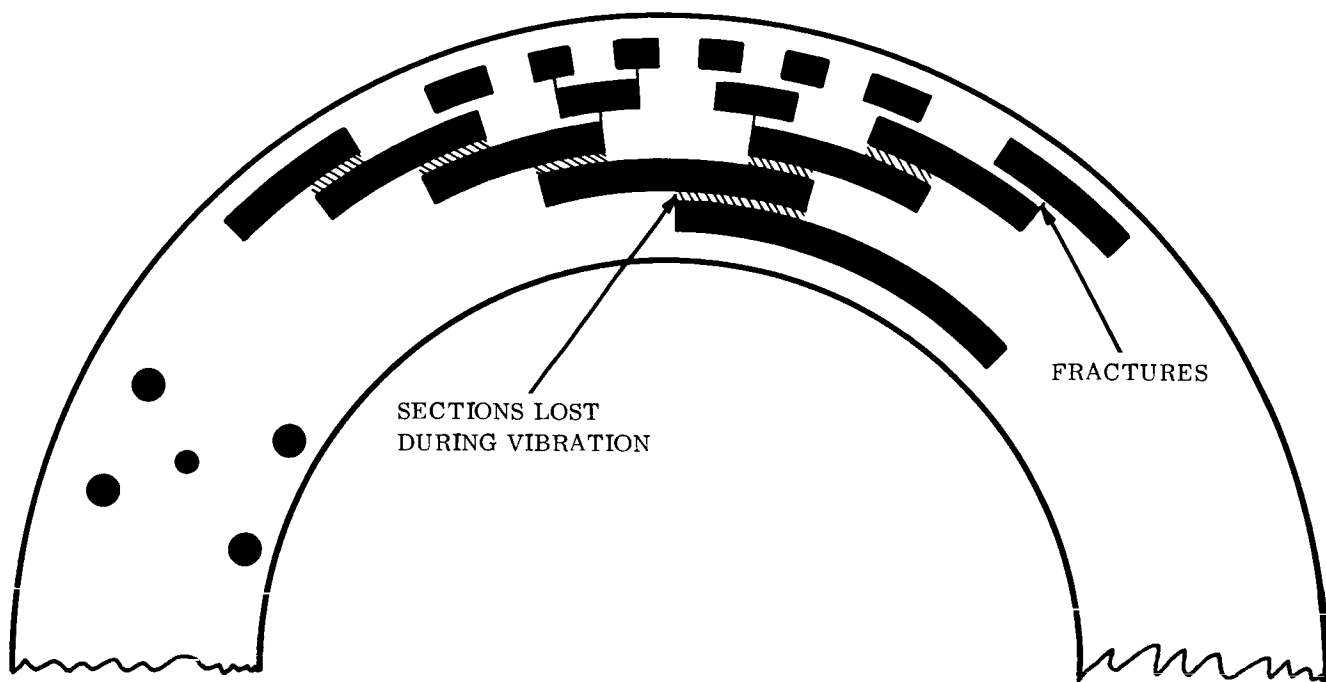
Figure 4-11. Original Encoder Disc Design

The encoder disc in the boom angle indicator broke in a number of places during vibration testing of the CPD Engineering Unit 1. This failure was the cause of improving the encoder disc both from the physical and material standpoint. A beryllium-copper disc was successfully subjected to vibration tests which exceeded qualification requirements.

in (a) and (b) above and this design is being fabricated in several materials for test evaluation. Comparison of Figures 4-11 and 4-12 will reveal that there has been some transposition of the various bits. These transpositions provide more physical support of all cut-out sections. The increased corner radii are also readily apparent in Figure 4-12.

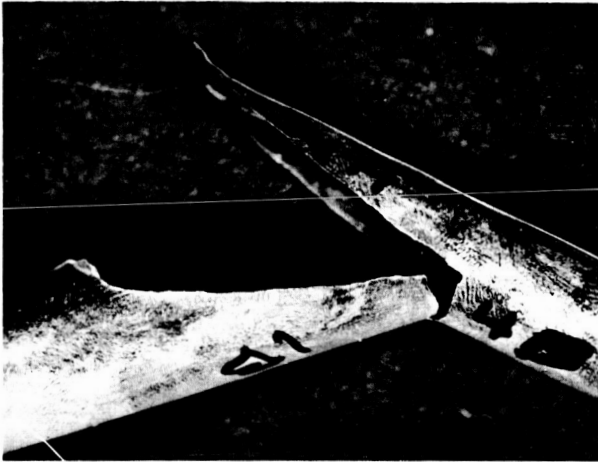
Figure A-1. Overall View of Failure Section Rod 1 (Magnification 1.5X)

The overall view of the failed section is shown in Figures A-1 thru A-4. Figure A-1 is a
